An overview of the hydrological framework of the Oak Protection project

Ivan Pilaš

Croatian Forest Research Institute

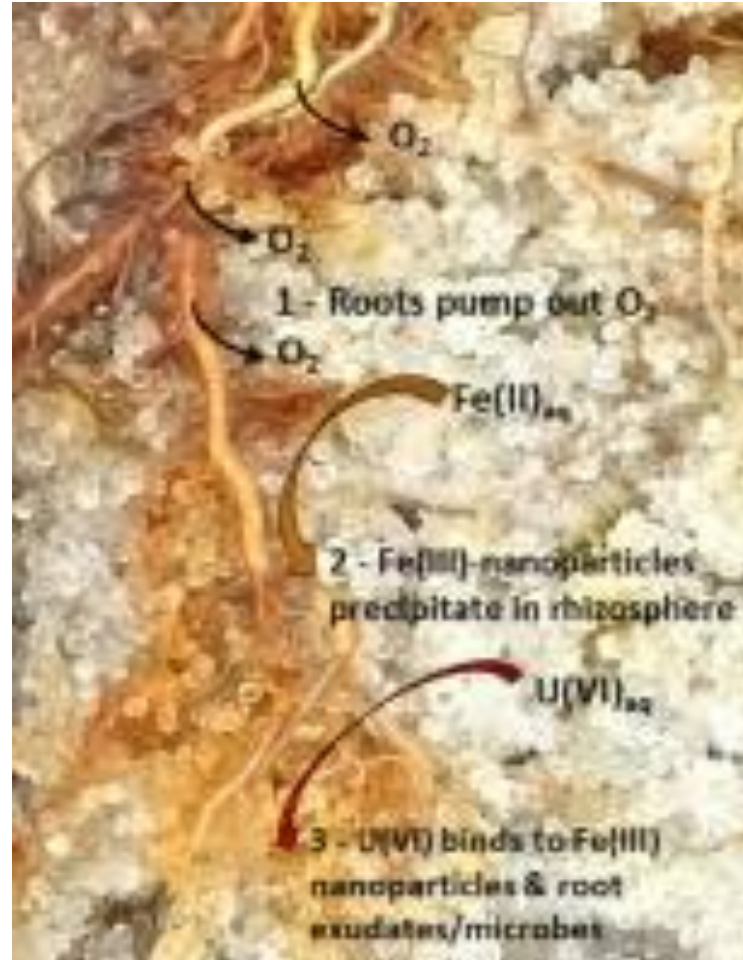
Root distribution of quercus robur in soils (Pilaš 2006)

Oxydized rhizosphere

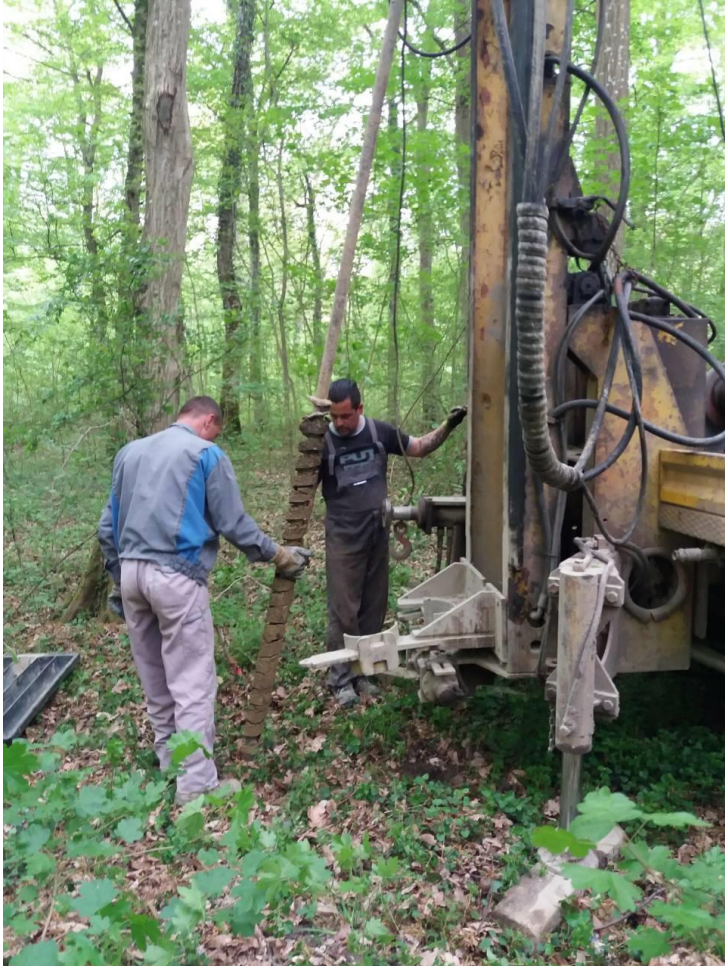
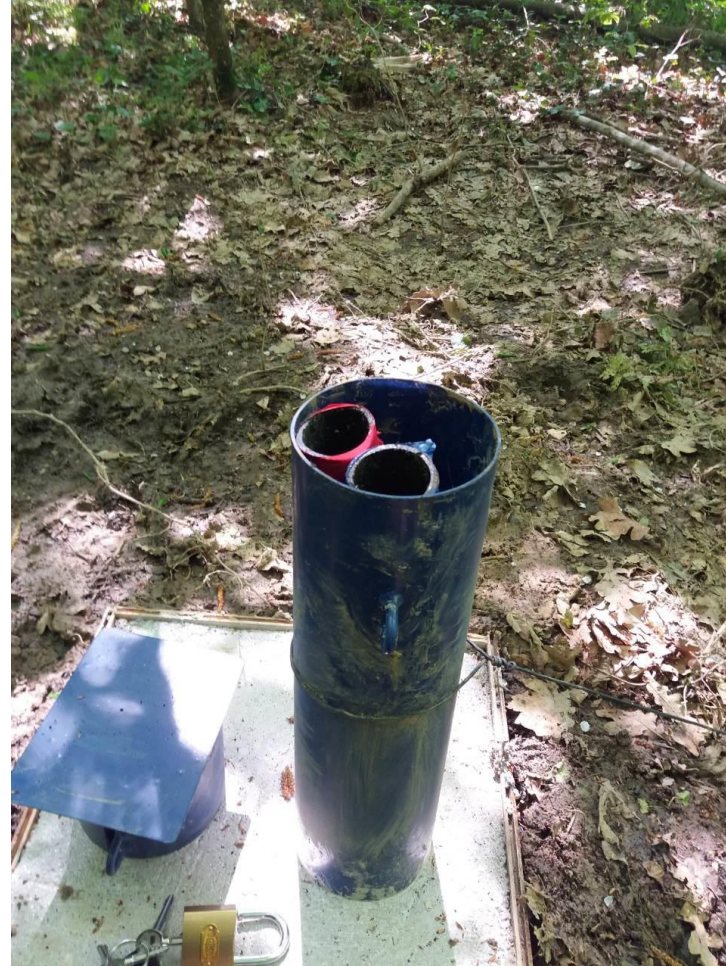
-Installation of new piezometers (6 Croatia, 30 Hungary) (Geolab d.o.o Varaždin)
DONE!

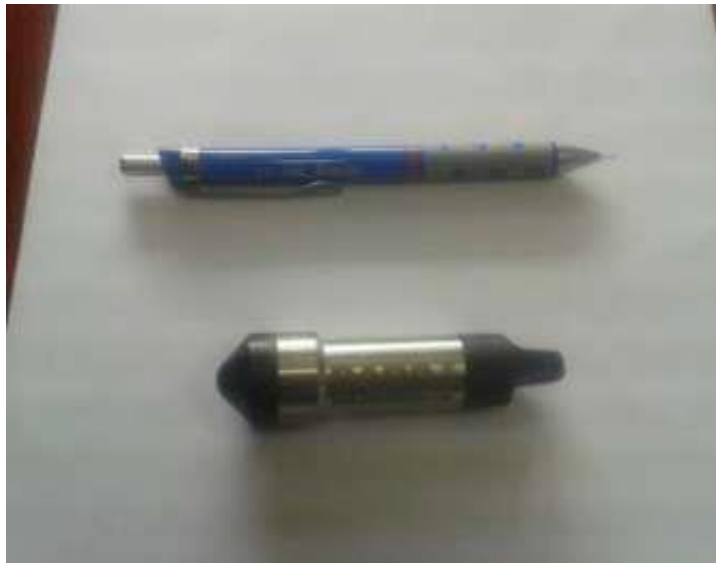
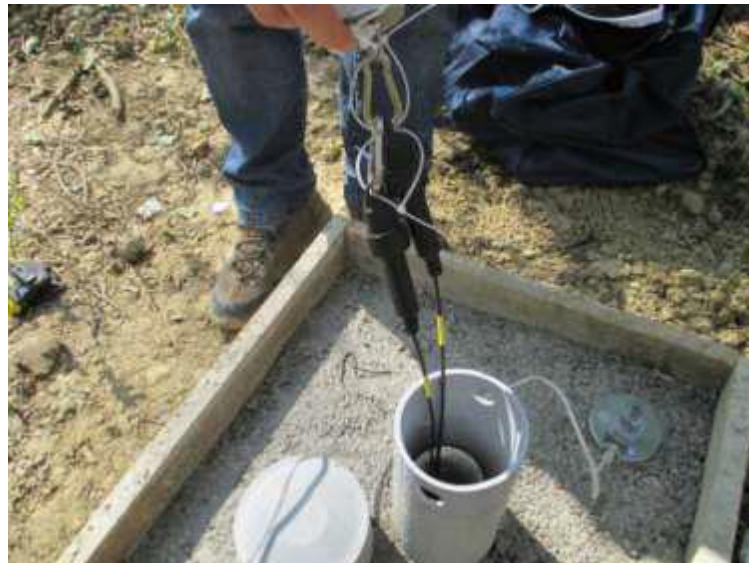
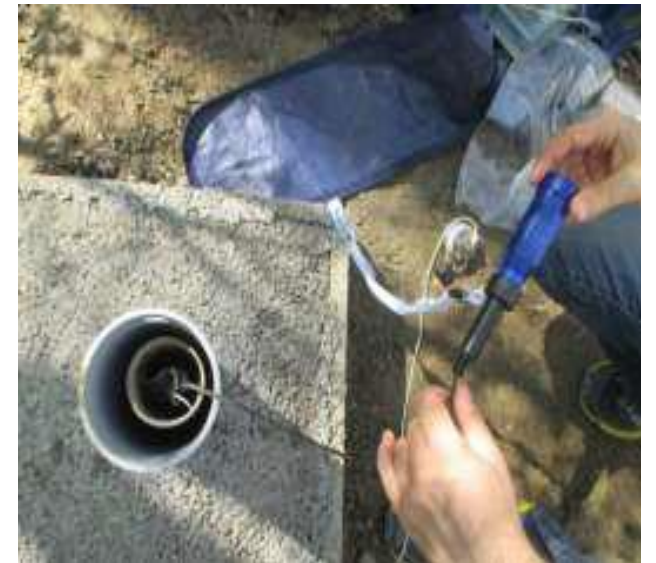
- Procurement and installation of 44 automatic groundwater loggers-divers (Megra d.o.o., Belgrade) – Procurement completed, installation of divers, beginning of July

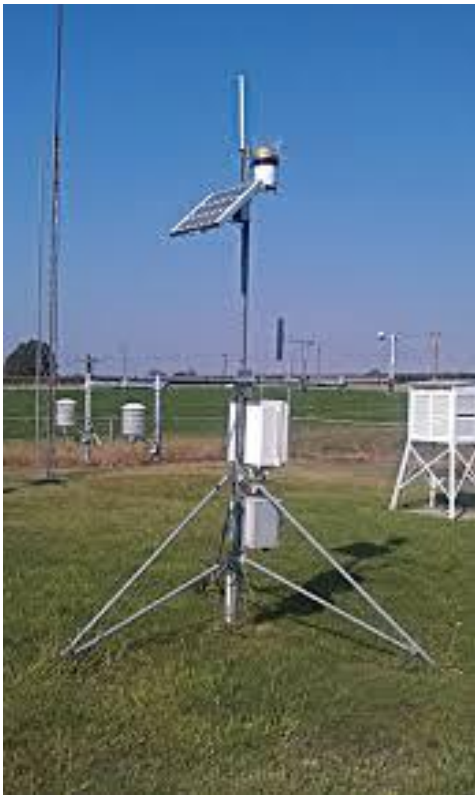
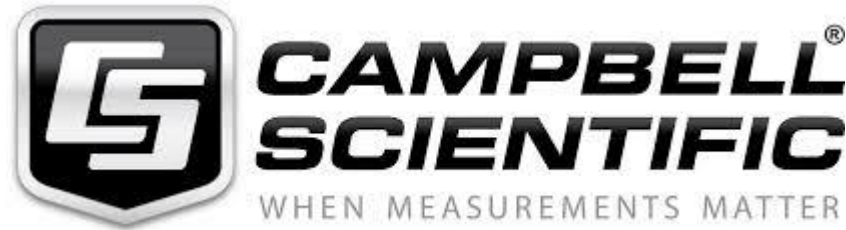
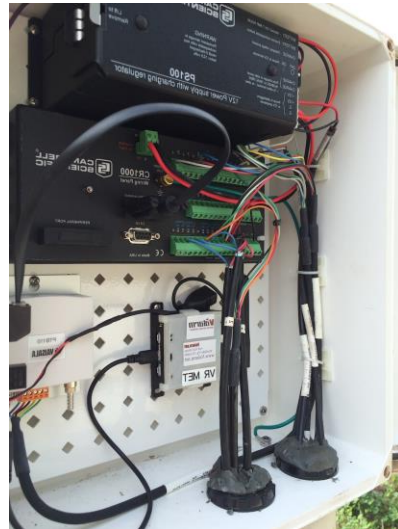
- Fully automatized real-time monitoring of the weather condition in forest areas on 7 weather stations (5 in Croatia, 2 in Hungary) Procurement completed
- Drought and extreme floods detection, weather condition suitability for pest and diseases infestation

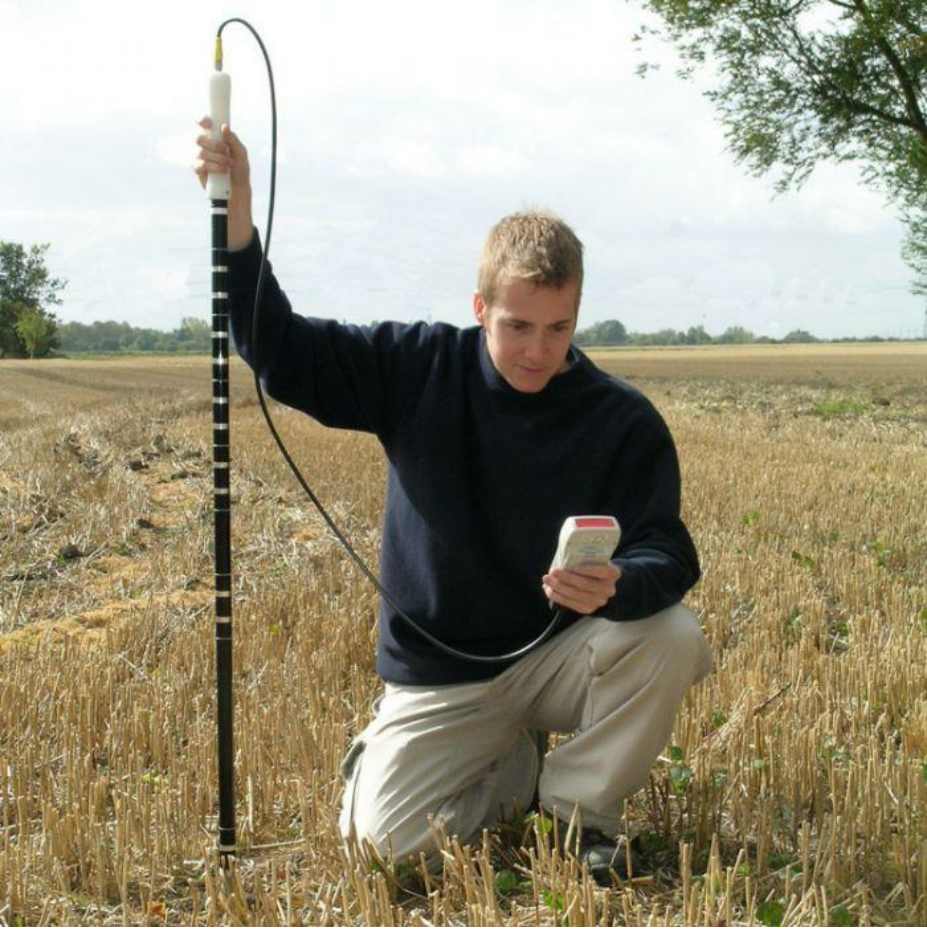
Soil moisture probe and additional tubes for soil moisture monitoring to 1 m depth on multiple locations (piezometers, nurseries, oak seed plantations...)

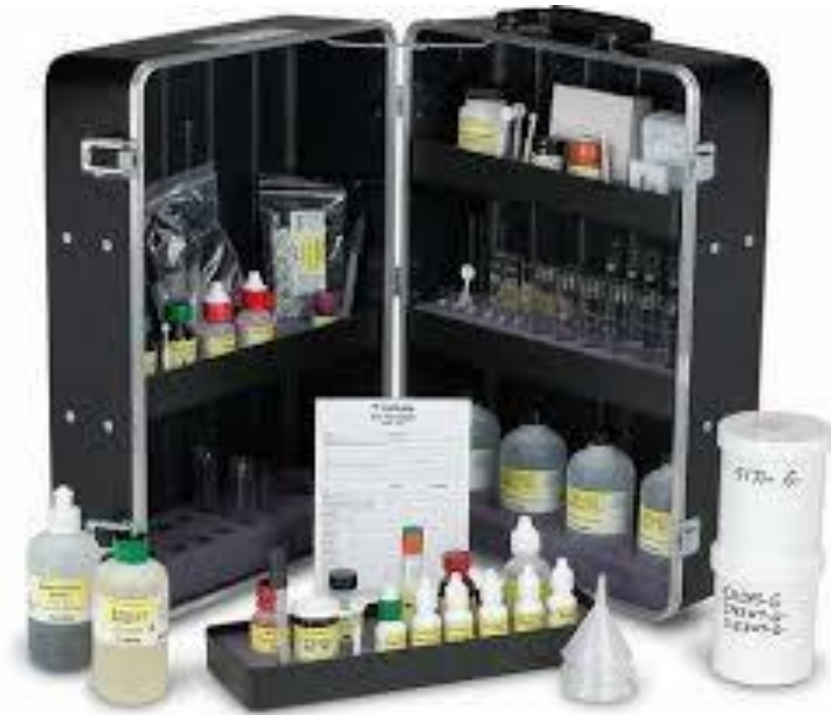
Portable soil test kit

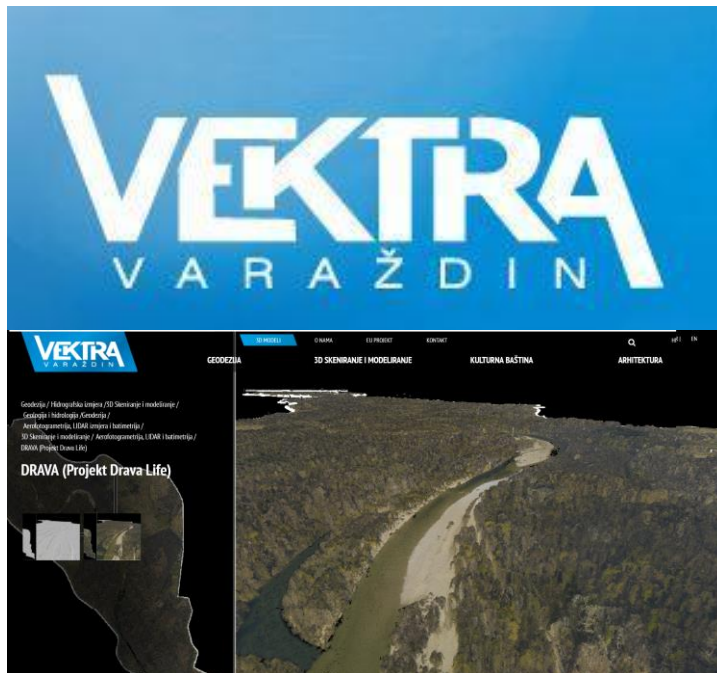
Lidar topografy 6000 ha:

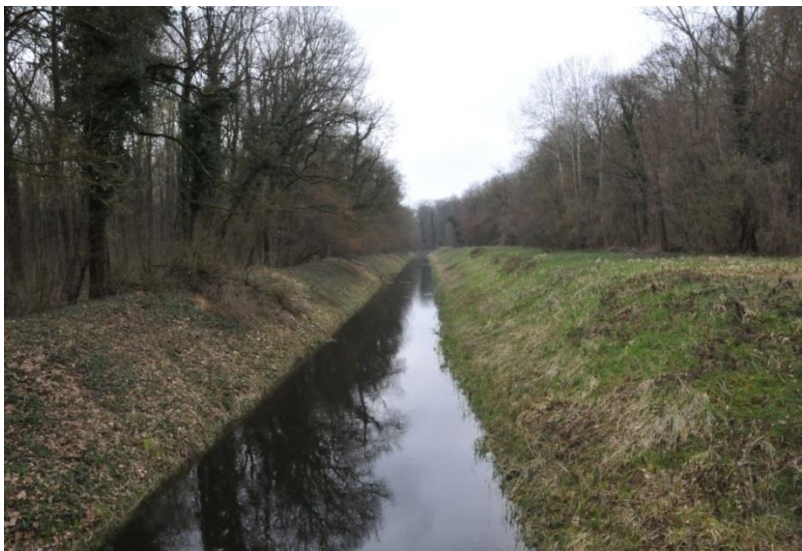
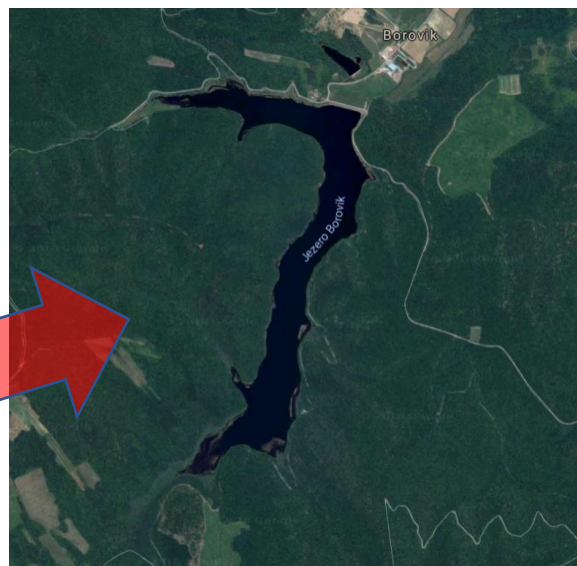
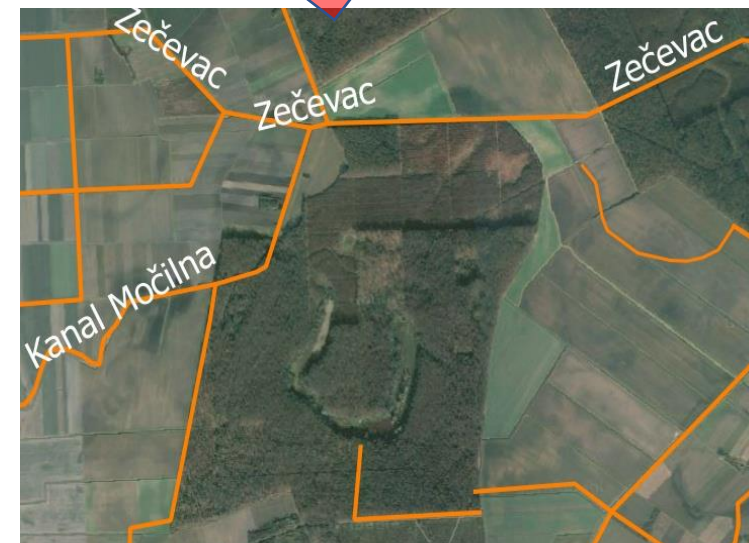
Reduction of natural flooding of forests by drainage canal Zečevac from Borovik water reservoir, dried out natural ponds, intensive decline of groundwater (G.J. Lacić Gložđe)
